**Date:** September 13, 2018

# **Confidential Inspection Report**

**123 Main Street  
Mytown, ON**

**Prepared by: Top To Bottom Home and Property Inspections  
3 Main Street West, Suite 1060  
Huntsville, ON P1H 0A3  
705-380-2578 [toptobottom.steve@gmail.com](mailto:toptobottom.steve@gmail.com)**

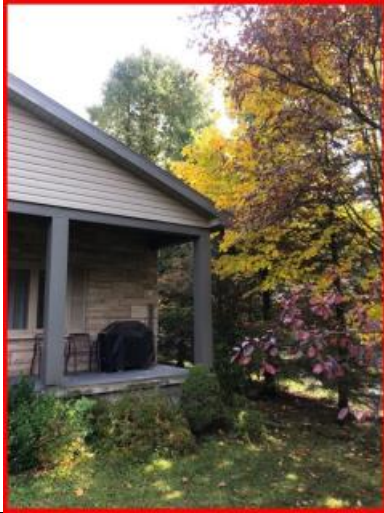
Trees overhang the structure need to be trimmed so that limbs, leaves, and rain will not drop off the tree onto the roof covering and clog the gutters, damage the roof, or promote moss growth. Trees that rub against the roof can cause severe damage and can drastically reduce the life of the roofing material. This also gives access to squirrels and raccoons.

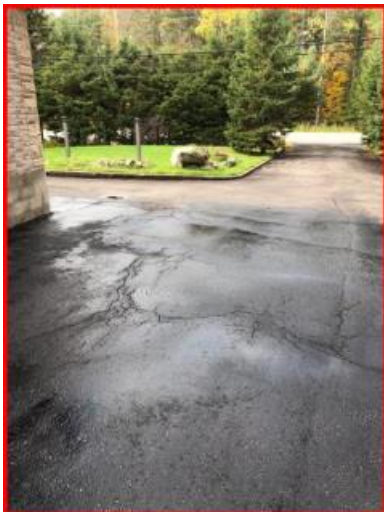
**Attention Needed** - The driveway needs attention and some maintenance to prevent further deterioration, The cracks in the driveway need to be sealed to prevent further damage. The freeze-thaw cycle may cause differential settlement and enlarge existing cracks.

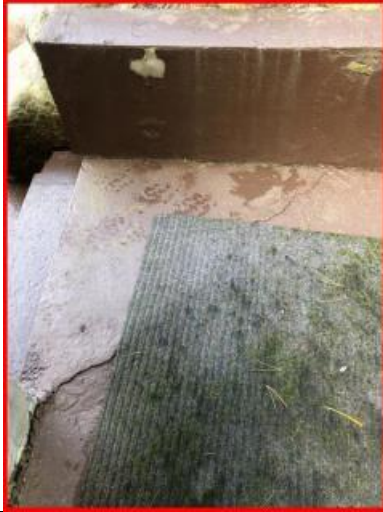
*Exterior Stairs Condition:* **Attention Needed** - The walkways need attention and minor repair to prevent further deterioration, The cracks in the walkways need to be sealed to prevent further damage. The freeze-thaw cycle may cause differential settlement and enlarge existing cracks.

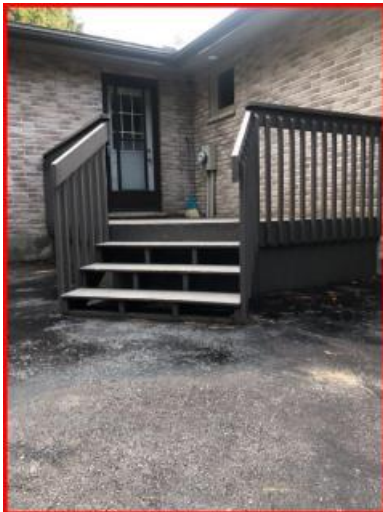
Rise and Run is not within code or is inconsistent for each step with more than 3/16" variance, Experience has shown that a rise of 7" to 7 1/2" (min 4/7/8" max 7 7/8") with a run of 9 3/4" to 10 1/4" (min 8 1/2") combines both comfort and safety.

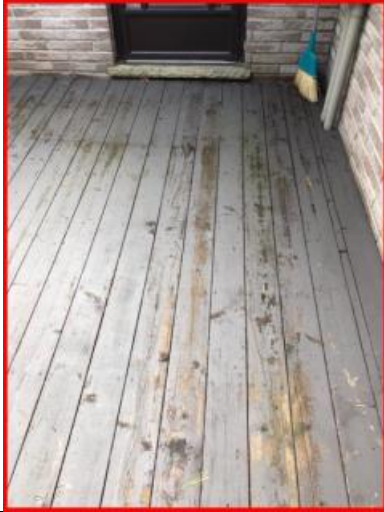
**Action Necessary** - The entryway stoop needs repair or replacement due to the following  
- Some wood components are deteriorated and will need to be replaced.

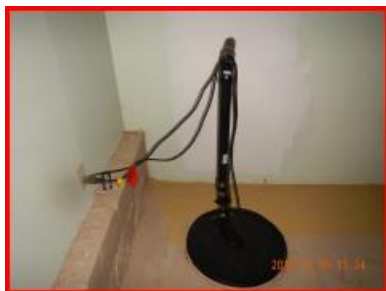
Yes, An alarm is recommended to warn of pump failure.

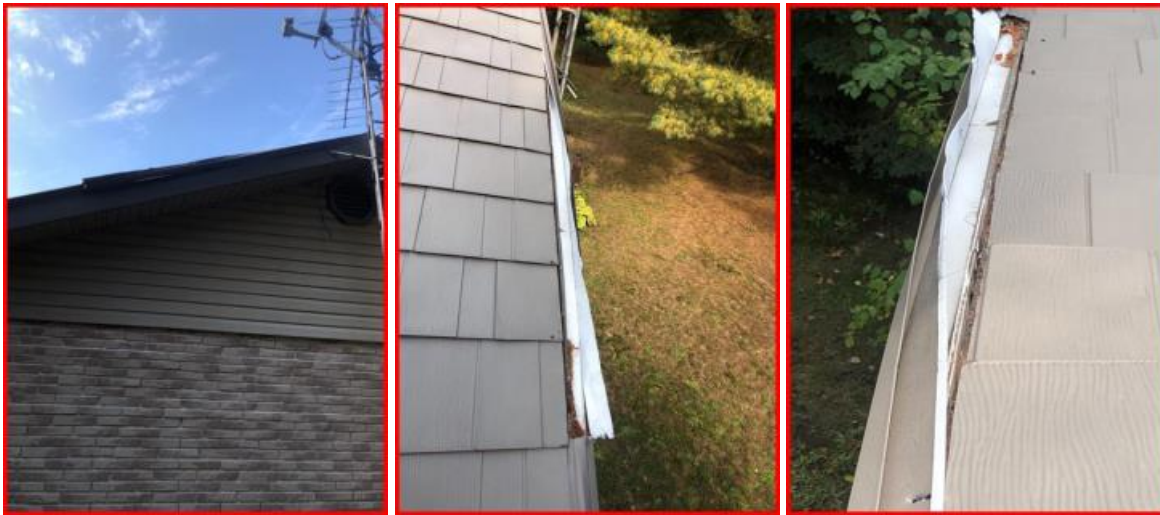
Improperly installed metal roofing - Placed directly on Shingles which is not recommended as the differential movement of the steel with temperature changes will loosen the fasteners.

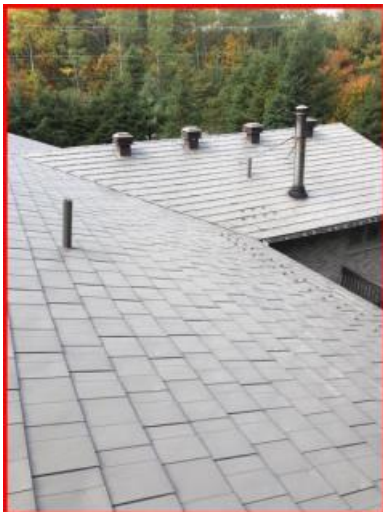
*Flashing:* **Attention Needed** - Due to tar or caulk covering, there is no way to determine the condition of the flashing under the sealant. The normal reason for this excessive sealant is to repair a prior leak. It should be watched over time in case it starts to leak. At that time repairs should be made.

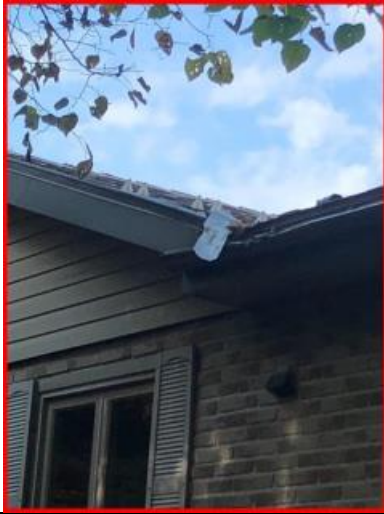
**Attention Needed** - The valley(s) shows wear that indicates repairs are needed.

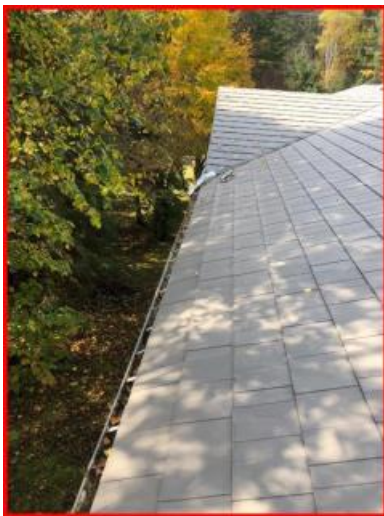
Clean debris from gutters, The gutters will need attention due to damage from ice, Add snow stops to steel roofing.

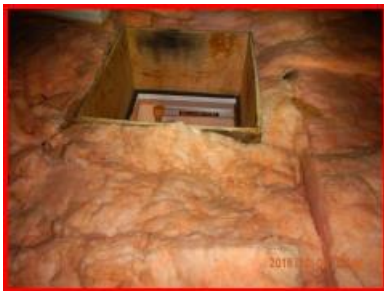
Ceiling scuttle hole, Insulation chase that holds back the loose fill insulation is not sealed warm air is leaking into attic.

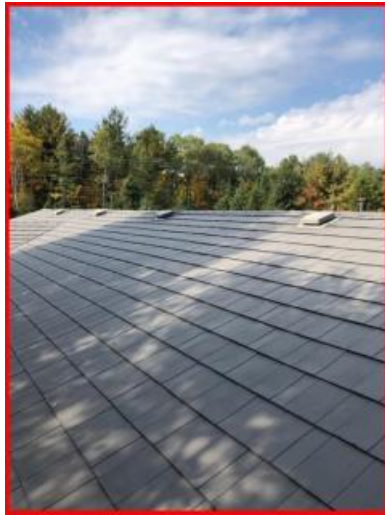
*Ventilation Hi/Low:* There are soffit vents installed, however sufficient air flow is not being achieved. Add newer cupola style static vents near the ridge, Once new static vents are installed the gable end vents will interfere with the flow of air from the soffit vents. Recommend closing the gable end vents inside attic.

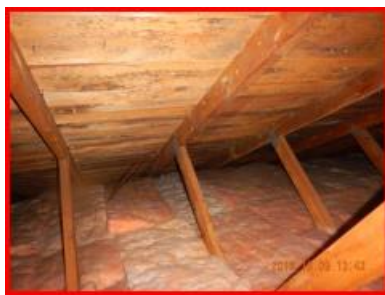
*Insulation Clear of Sheathing:* The insulation is in contact with the roof sheathing. This condition needs to be changed. There needs to be at least a 1 1/2" air gap between the insulation and the sheathing. This contact would lead to condensation in the attic during winter months. It also limits airflow which ventilates the attic and reduces the life of roofing materials, Add baffles in the rafter bays to maintain the 1 1/2" clearance.

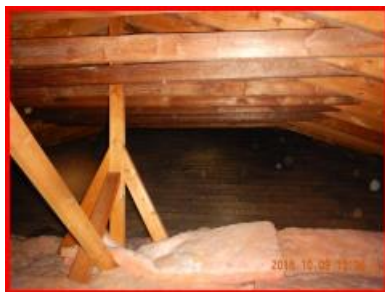
*Comments* The adjacent attics should be opened up to assist with air movement.

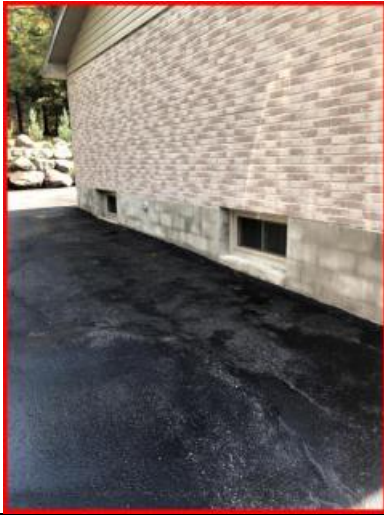
*Basement or Crawlspace Windows:* The basement windows are either at or close to exterior grade this creates the possibility of water intrusion and deterioration of the window frames. Steps may need to be taken to prevent future problems.

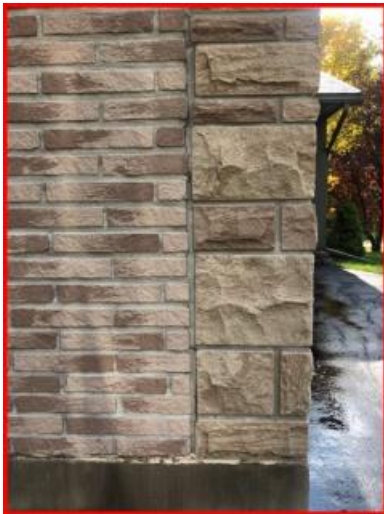
Satisfactory - There appears to be adequate clearance between the earth and the wood.  
**Attention Needed** - Several spots around the structure were noted that need to be caulked, Caulk should be applied to areas where brick and wood siding meet, trim around window frames or doors, and piping and service penetrations. Also, any cracks that allow moisture or wind entry should be caulked to prevent deterioration.

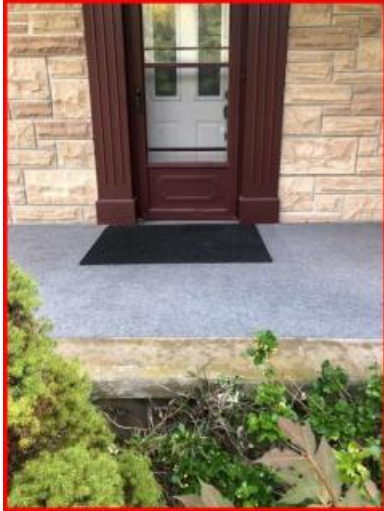
Deck is too close to same height as doorway allowing moisture to rot threshold especially with snow and ice build up in winter. This problem can also cause damage to siding and the wall structure.

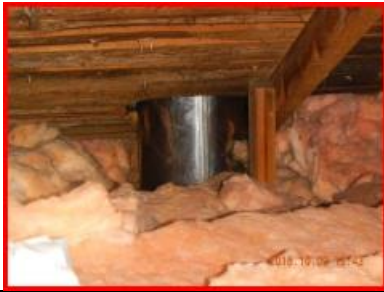
The required 2 inch clearance from combustibles has not been achieved. The attic insulation shield is missing.

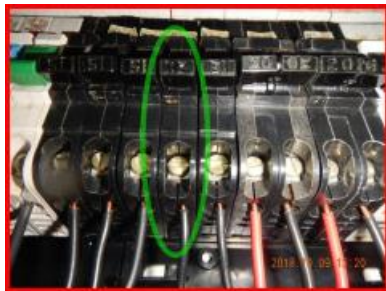
*Breaker/Fuse to Wire Compatibility:* **Action Necessary** - The breakers/fuses in the main power panel are inappropriately matched with wire gauges that are too light for the breaker/fuse allowed draw. An overdraw condition could cause melting, insulation overheating, or fire. IMMEDIATE ACTION IS REQUIRED.

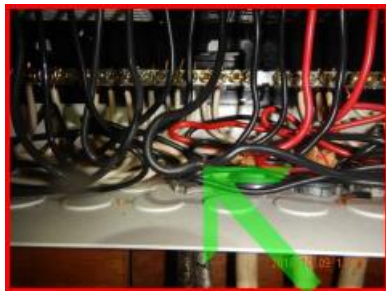
*Condition of Wiring in Panel:* **Action Necessary** - Electrical circuitry wiring in the power panel shows some condition that calls for the immediate action of a qualified licensed electrician, Bare or damaged conductor insulation.

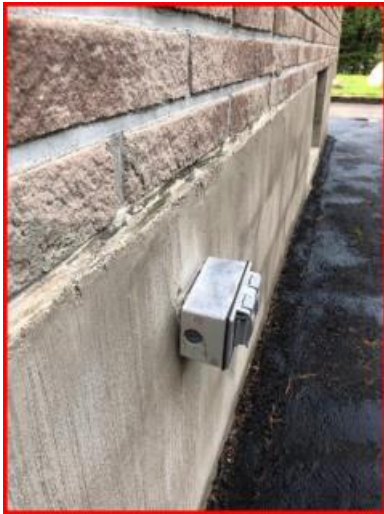
Yes there are exterior electrical outlets, Predate - This structure predates the requirement for newer construction of Ground Fault protected outlets. For safety reasons, they should be installed in the following locations: Any outlets within 1.5 meters of a water source including circuits in the kitchen (except refrigerator), bathrooms, and laundry as well as all exterior locations except those listed in Electrical Safety Code. For more information on Ground Fault Circuit Interrupt protected outlets, contact this inspection company. The cable penetrating the concrete wall is not installed properly, Weather tight seal at siding is required.

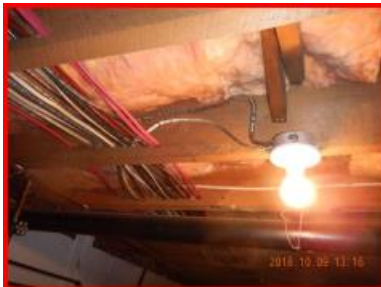
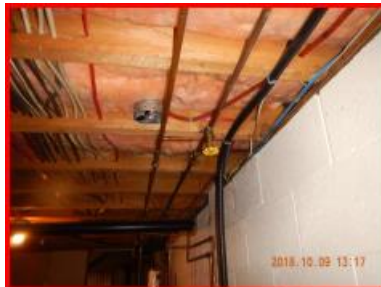
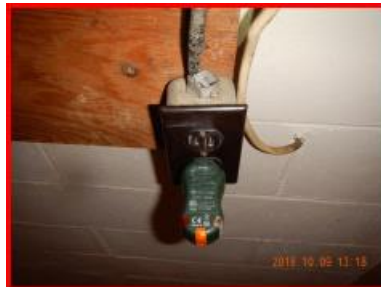
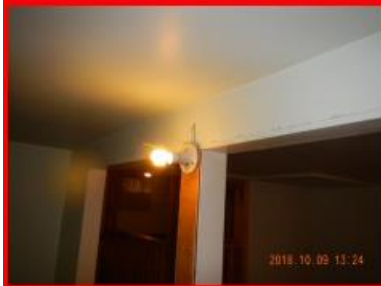
Bare light bulbs in storage areas and low ceilings are considered a safety hazard. Consider replacing bare light bulbs in these areas with an appropriate fixture.

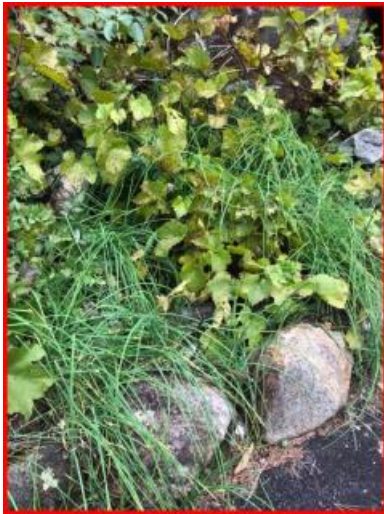
Is a Grass Buffer present and is it at least 12 feet around the well head - No.

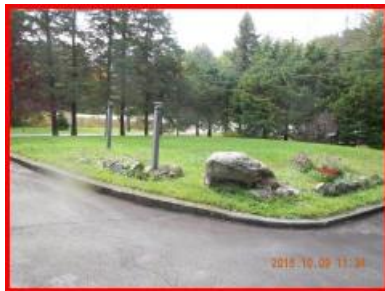
No - Effluents were not noted at the surface in the lateral field area. There is evidence of poor absorption or percolation of effluent in lateral field runs as the runs are creating prominent narrow vegetation growth. Using a product called Bio-Dislove may give some extra time before the system needs to be replaced.

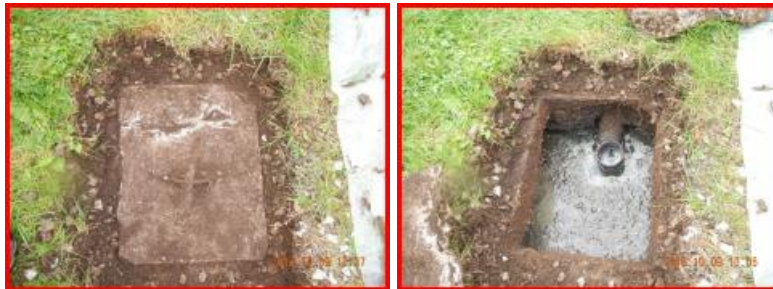
The following conditions were observed at the outlet of the septic tank: After completing the flow test the fluid level is higher than the outlet pipe, which may be due to a blocked or flooded lateral field and possible bio-mat. **Further investigation by a qualified contractor will be required to determine the cause and repair.**

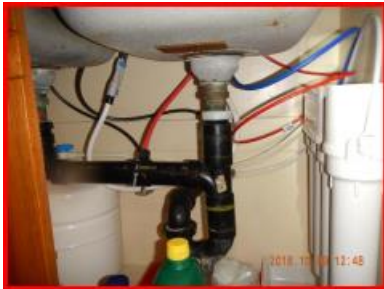
There is deterioration of the drain pipes under the sink. Although there is currently no leak, there may be one in the future.

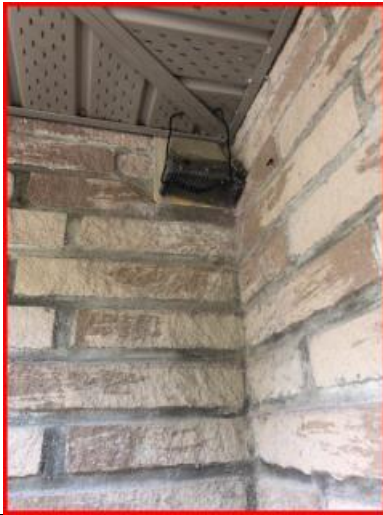
The dryer ventilation as installed appears to need cleaned. A vent clogged with lint can create a fire hazard.

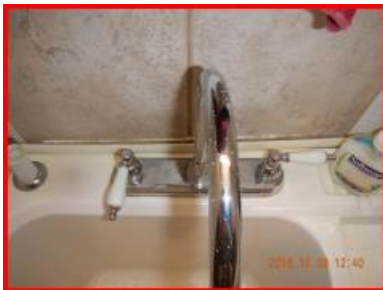
Yes - There is a laundry basin installed, The unit is functional. No leaks were noted. Caulk at wall required.

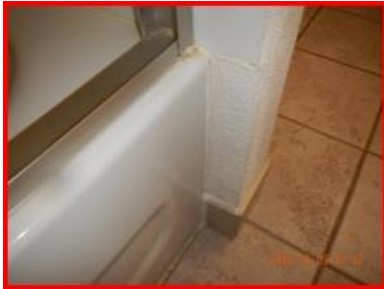
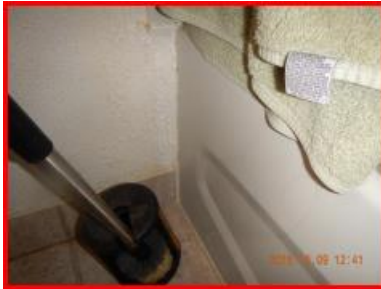
**Action Necessary** - Some caulking in the water contact areas is necessary. There may be current damage. This inspection is of the visible areas only. No invasive action was taken.

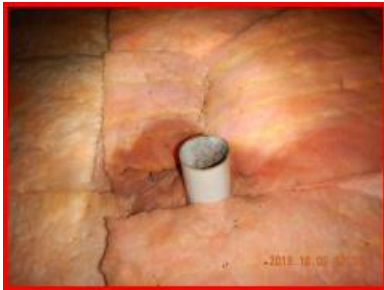
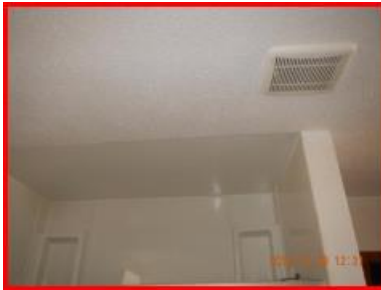
The ventilation fan vents into the attic space. This introduces moisture into the attic that must be removed from the attic. It needs to vent outside at a gable end rather than the attic.

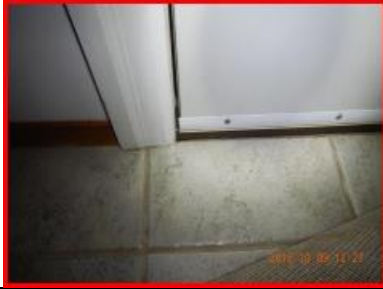
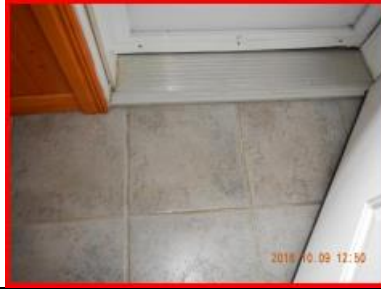
Tiled areas both vertical and horizontal surfaces should have caulk not grout in joints along inside corners and where two different materials meet.

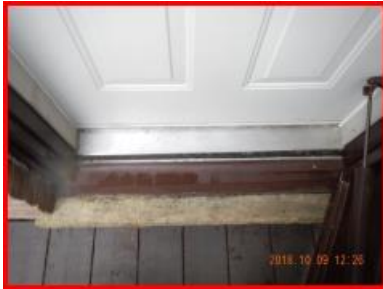
Threshold and the casing need attention because wear and damage and the possibility of water eventually causing deterioration of materials and structure below- replace damaged materials and seal to weatherproof.

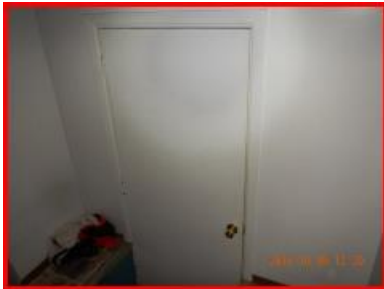
Closure: No - For safety to prevent off gases from garage entering into living space recommend spring loaded closure hinges or hydraulic door closer be installed and in working order.

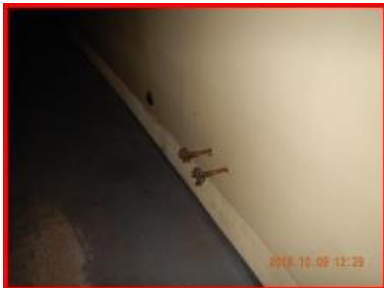
Yes - There is a water source installed in the garage. The installed water supply piping is not properly insulated for freeze protection.
