Report: Sample 0002

Inspection Address: 321 Old Road, Mytown, ON

Date: May 12, 2018

Confidential Inspection Report

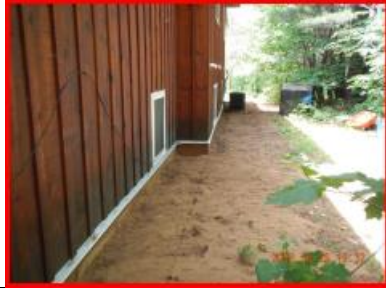
Do not allow large amounts of snow to accumulate on this side of the house. It will be slow to melt due to lack of sunlight and may form ice. This preventative maintenance will limit the possibility of water or ice damage.

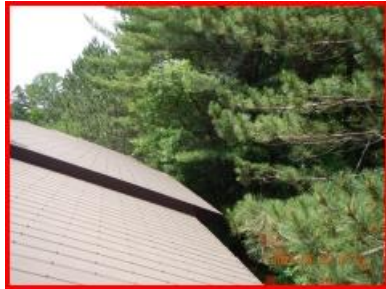
Trees Condition:

Trees overhang the structure need to be trimmed so that limbs, leaves, and rain will not drop off the tree onto the roof covering and clog the gutters, damage the roof, or promote moss growth. Trees that rub against the roof can cause severe damage and can drastically reduce the life of the roofing material. This also gives access to squirrels and raccoons.

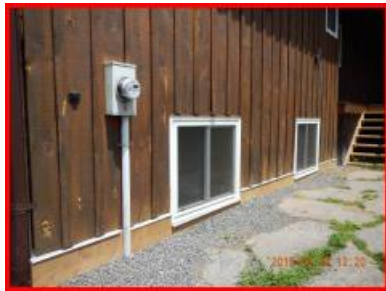
Action Necessary - The walkway slope is such that water either does not run off or run-off is directed towards the house. This run-off may interfere with the foundation. The walkway should slope to allow water to run away from the structure and foundation.

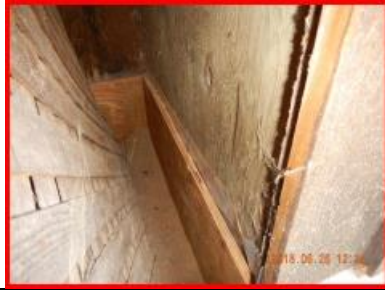
Permanent Wood Foundations - Chemically treated to resist rot, moisture, and insects; wood framed and plywood sheathed walls have been constructed in Canada since 1950 and are still in satisfactory condition if run off water at grade is managed and controlled properly, the poly moisture barrier is applied correctly on the exterior, backfill material and installation is correct, and a properly installed drainage system at the footing is present. The poly is not folded down on to its self to give a double layer where secured. End cut needs to be treated with preservative.

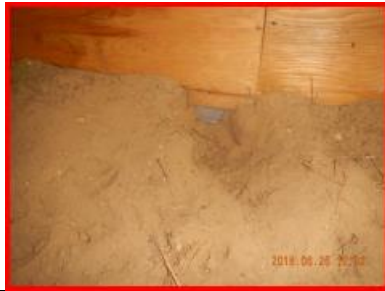
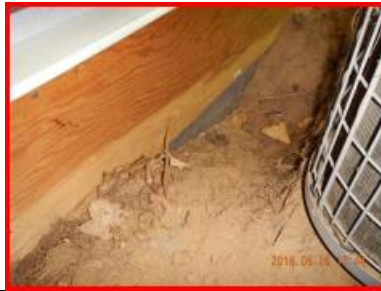
Visible Portions of Foundation Walls:

Exterior Permanent Wood Foundation - Polyethelene sheeting acts as a slipsheet for water that comes in contact with the foundation; its not a waterproofing material. The sheeting must be protected with a wood board for eight inches above the surrounding grade, and at least four inches below. Newer PWF use waterproof membrane or dimpled drain screen. Repair any damaged poly.

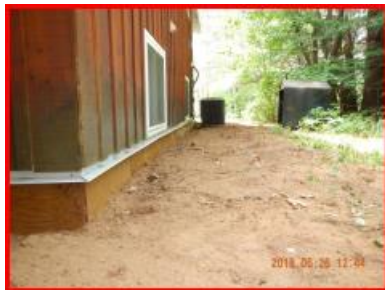
Action Necessary - The drainage around the foundation needs immediate adjustment in order to divert the run-off water away from the foundation. Ground slope should be adjusted to a rate of at least 1/2 inch per foot for 6 feet away from the foundation.

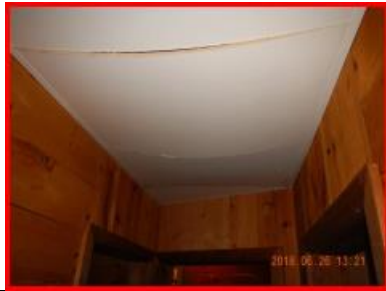
Missing T bars.

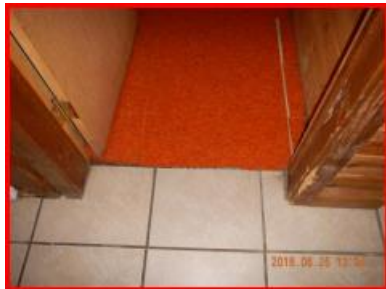
Do It Your Self work. Have a qualified licensed technician perform repairs and upgrades.

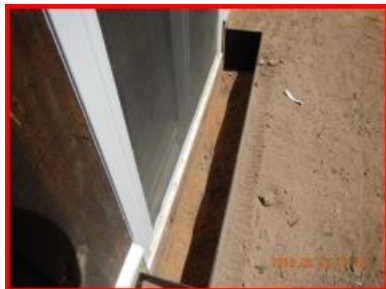
Basement Windows:

The basement windows are either at or close to exterior grade this creates the possibility of water intrusion and deterioration of the window frames. Steps may need to be taken to prevent future problems.

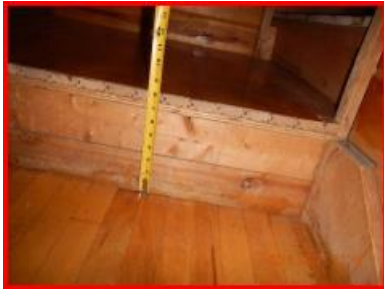
Staircase Condition:

Rise and Run is not within code or is inconsistent for each step with more than 3/16" variance, Experience has shown that a rise of 7" to 7 1/2" (min 4 7/8" max 7 7/8") with a run of 9 3/4" to 10 1/4" (min 8 1/2") combines both comfort and safety.

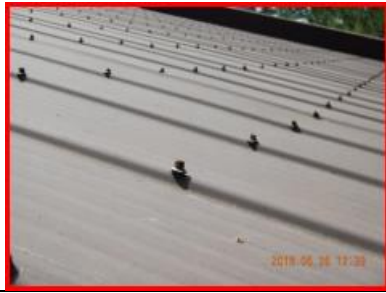
Type Roof: Gable.
Roof Covering Materials: Metal Roofing. Metal may consist of copper, aluminum, or stainless steel. Some have a protective coat to prevent rust and deterioration. It is usually installed in vertical panels with some fashion of overlapped seams.
Cover Layers: The roof covering on the main structure appears to be the first covering.
Condition of Roof Covering Material: Some fasteners are loose and will need tightening or replacement.

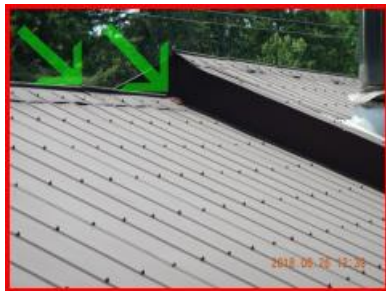
Ridges: **Attention Needed** - Some portion of the ridge(s) needs attention.

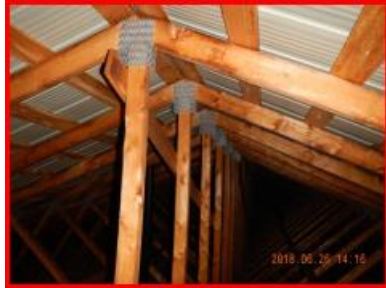
Ventilation Hi/Low: There are soffit vents installed, There is no upper ventilation at the ridge and therefore no air is escaping the attic space at this upper level. This means there is essentially no attic ventilation
The steel ridge cap is not designed to be a ridge vent, however it does allow some air to vent at the upper level. Installing a metal ridge vent will create better attic ventilation and improve the health of the attic as well as cooling costs in summer, Add newer cupola style static vents near the ridge.

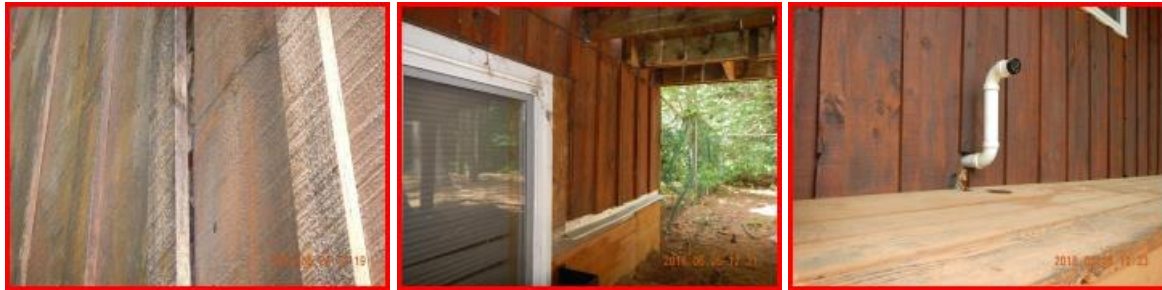
Type of Construction: Frame.
Exterior Siding Materials: Wood.
Siding Condition: Board/Batten, **Action Necessary** - Some portion of the exterior siding material or finish is in a deteriorated condition that requires repair or replacement. Boards are too far apart and battens have deteriorated exposing the OSB sheathing.
Air barrier missing - OSB sheathing exposed. Repairs are necessary
OSB sheathing is not designed for use at grade or exposure to the elements
Exposed OSB sheathing is susceptible to moisture and rot.
Damage noted - repair or replace.

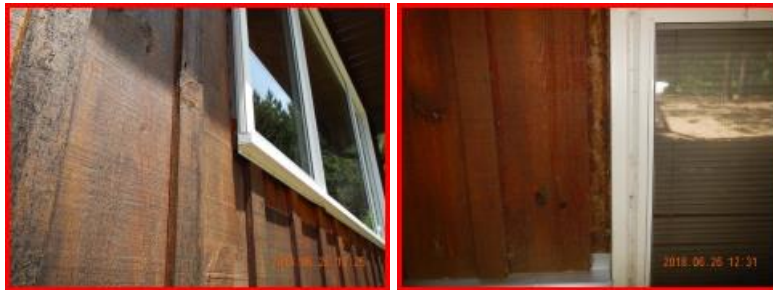
Trim Condition:

Action Necessary - There are some trim components that are missing. These need to be replaced. Their function is generally to protect seams where two surfaces meet.

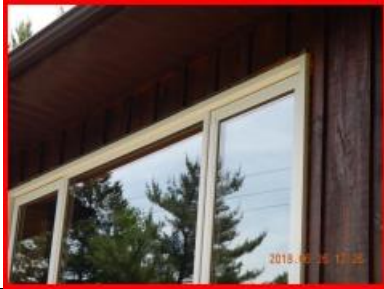
Drip cap flashing is missing - needs to be weather tight to prevent water intrusion.

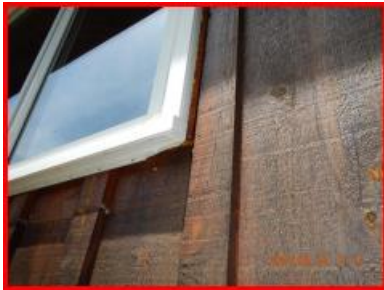
Window Flashing and Sills:

Action Necessary - Some portion of the window flashing is not correctly installed, or it is not functioning as intended.

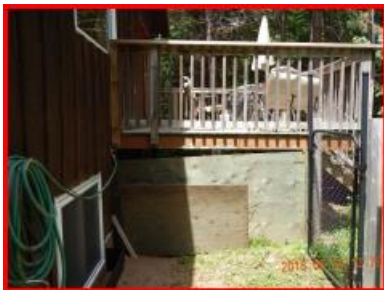
Deck.
Improper conditions viewed.

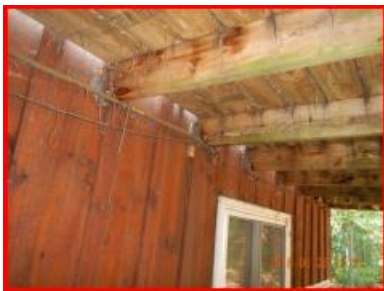
Action Necessary - Some portion of the framing in the deck or porch is in a condition that warrants immediate repair.

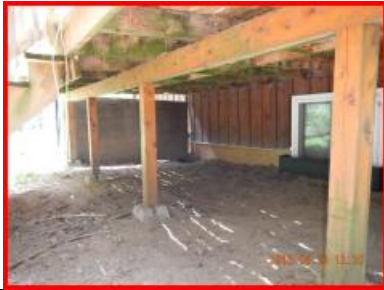
The Foundation Materials:

This deck assembly is fastened to the structure which is set on proper footings below frost. The deck assembly is set on concrete bases which are on grade that frost can cause up and down movement - it should be set on proper poured concrete tube style footings that are below frost to prevent damage.

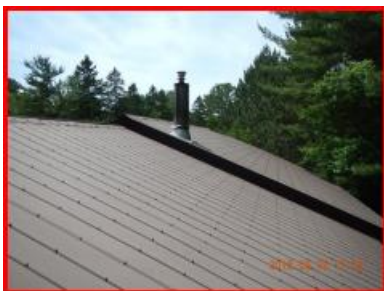
Chimney Exterior: Metal pre-fabricated.
Flue: The chimney flu is lined with metal.
Flashing: Improper installation - metal roofing should overlap flashing at least half the way down.

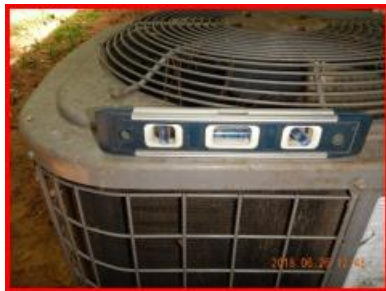
Type: Refrigerator/Split System. Electricity-powered.
Unit Tested: Yes.
Insulation Wrap on the Suction Line: Satisfactory.
Condenser Clear of Obstruction: Satisfactory.
Condenser Cabinet Level: **Action Necessary** - The condenser pad should be solid and within 5-10 degrees of level. The current condition does not allow stability and may prohibit adequate lubrication. Action is recommended before continued use.

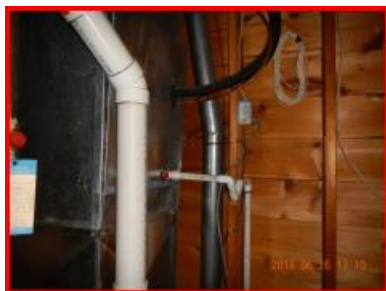
Heating System Location: Basement, The furnace switch is not located correctly between the furnace and the exit of the room where the furnace is located.

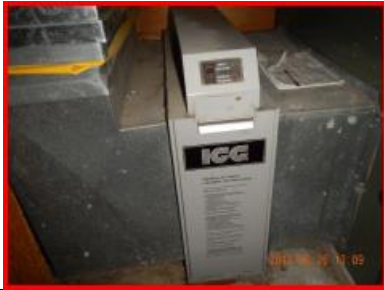
Electronic Air Cleaner Installed: Yes - There is an electronic air cleaner installed. The efficiency and effectiveness of these far exceed that of conventional filters. Cleaning on a regular basis is still required. Check with the manufacturer or service technician for recommended service and cleaning. It does not function. Recommend it be removed or repaired.

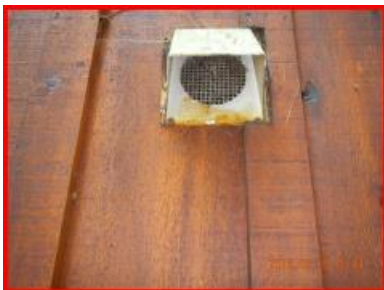
Inlet and Outlet Vents Inlet vent requires cleaning at least annually - a clogged vent will hinder the performance and possibly cause damage.

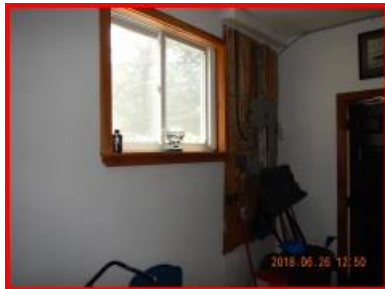
The electrical panel box is temporarily blocked. For safety reasons, be sure that there is a clear and ready access to the panel. The power panel should be installed in a manner to allow safe and quick access for operation, repair, or inspection without having to climb over or remove obstacles. This is according to current safety standards. The floor area 1 meter in front of the panel must be kept clear and the panel may not be located above any appliance or counters or similar objects.

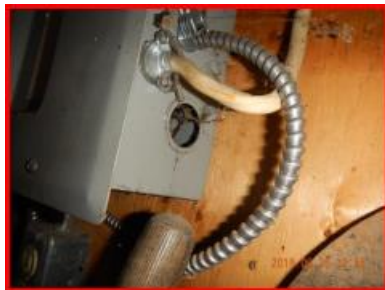
Panel Condition:

Action Necessary - The power panel, as a container for safely covering circuitry and components, requires immediate action to minimize the possibility of electrical shock. There are missing knock-outs in the panel enclosure.

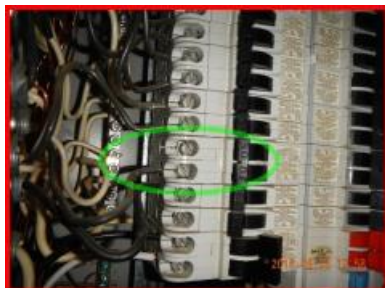
Action Necessary - The breakers/fuses in the main power panel are inappropriately matched with wire gauges that are too light for the breaker/fuse allowed draw. An overdraw condition could cause melting, insulation overheating, or fire. IMMEDIATE ACTION IS REQUIRED.

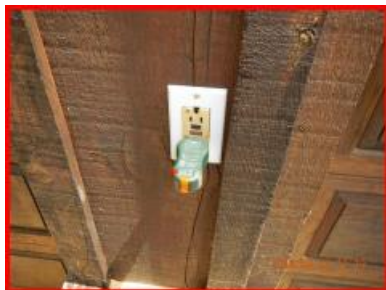
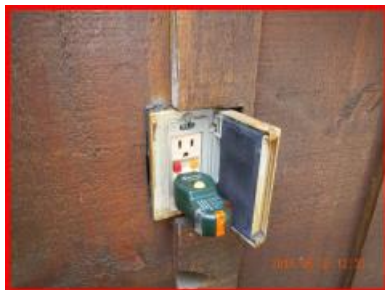
GFCI did not trip when external test was conducted. Weatherproof cover missing. Recommend upgrading this weatherproof outlet cover to the new in-use weatherproof cover.

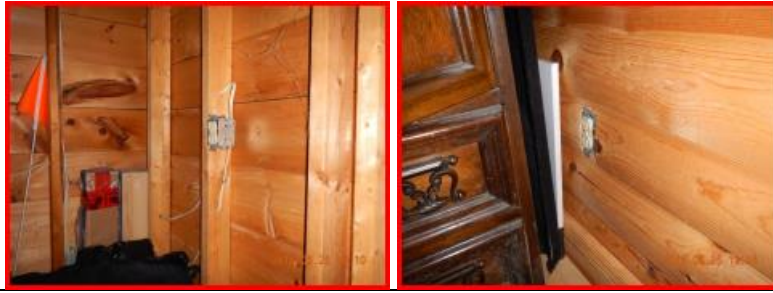
Interior View of Basement: Missing or damaged outlet and switch plates.

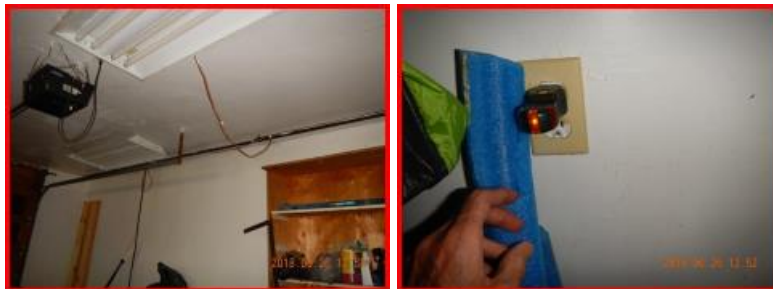
Action Necessary - At least one outlet tested in the garage needs to be replaced.

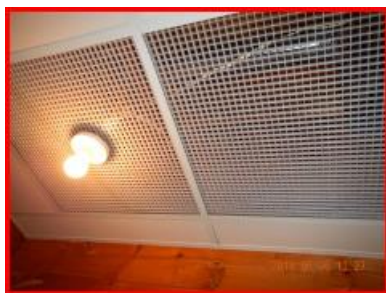
Bathroom #3: Have a qualified licensed technician investigate and perform repairs or upgrades. **Action Necessary** - The ceiling light in this bathroom has an exposed bulb. Exposed bulbs are not allowed in any areas that may be accessible to water. Immediate action is necessary.

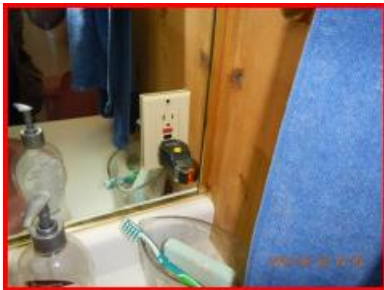
Action Necessary - There is a Ground Fault Circuit Interrupt outlet installed in the area of the bathroom lavatory. However, it failed to stop the current flow or did not reset after testing. Replacement is necessary.

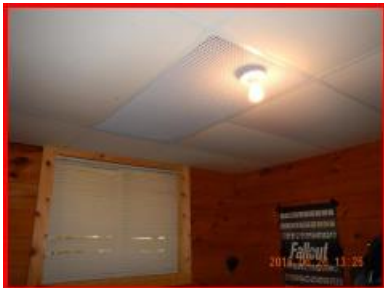
Have a qualified licensed technician investigate and perform repairs or upgrades to lighting.

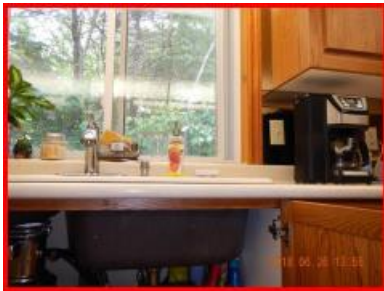
Faucet is not secure.

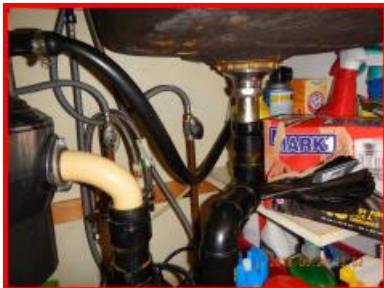
Sink and Drain Lines:

No P trap between sink and food disposal.
Suspect DRAIN LINES- S-TRAP PRESENT: An S-trap is found in the drainline under the sink. S-traps have a tendency to siphon out the liquid seal in the trap when a basin of water is emptied. They are no longer used in new construction and should be eliminated where practical when renovations or plumbing repairs are under consideration. In the meantime, simply running a bit more water down the drain after a basin of water drains will act to restore the liquid seal in the trap in the event siphoning occurs.

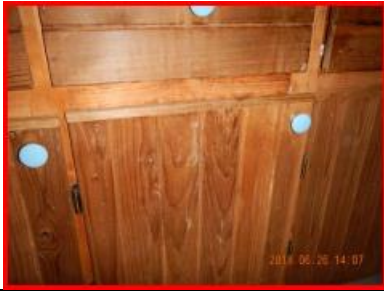
Adjust doors.

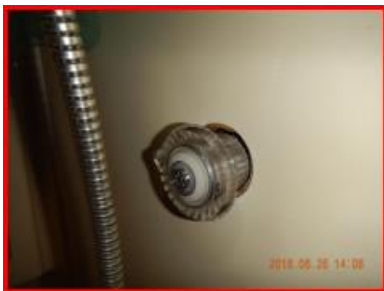
Escutcheons are missing at wall - water intrusion behind wall is possible.

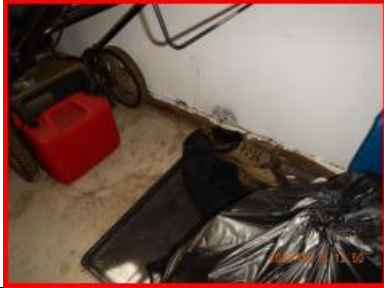
Garage Walls Condition: **Action Necessary** - There is evidence of leakage in at least one wall. The stain appears to be from a current leakage.
