**Date:** September 13, 2018

# **Confidential Inspection Report**

**123 Main Street  
Mytown, ON**

**Prepared by: Top To Bottom Home and Property Inspections  
3 Main Street West, Suite 1060  
Huntsville, ON P1H 0A3  
705-380-2578 [toptobottom.steve@gmail.com](mailto:toptobottom.steve@gmail.com)**

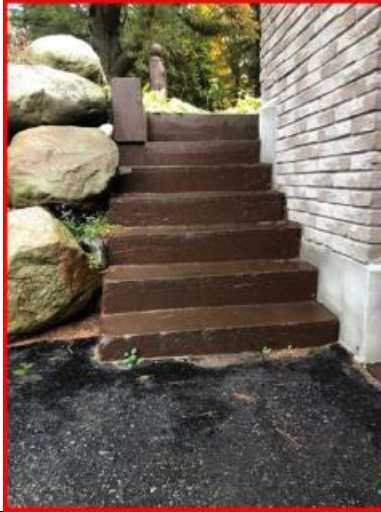
*Entryway Stoop Materials*  
*Entryway Stoop:*

Rise and Run is not within code or is inconsistent for each step with more than 3/16" variance, Experience has shown that a rise of 7" to 7 1/2" (min 4/7/8" max 7 7/8") with a run of 9 3/4" to 10 1/4" (min 8 1/2") combines both comfort and safety.

**Action Necessary** - The entryway stoop needs repair or replacement due to the following  
- Some wood components are deteriorated and will need to be replaced.

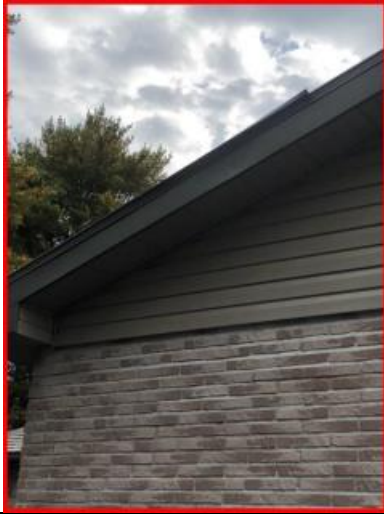
<i>Type of Construction:</i>	Frame.
<i>Exterior Siding Materials:</i>	Brick.
<i>Siding Condition:</i>	Good - The exterior siding materials are of a better grade or condition than I would normally expect to see.
<i>Trim Condition:</i>	Satisfactory - The trim is intact and satisfactory.
<i>Soffit/Eaves:</i>	Satisfactory - The soffit/eaves appear to be in satisfactory condition and show only signs of normal wear.
<i>Fascia &amp; Rake Boards:</i>	Metal fascia installed on rake with lap in wrong direction allowing water to run behind.

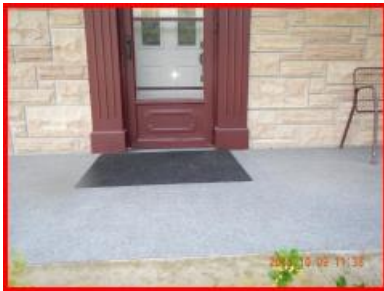
<i>Condition of Painted Surfaces:</i>	Satisfactory - The finish or exposed painted surfaces are satisfactory.
<i>Outside Entry Doors:</i>	Satisfactory - The outside entry door(s) is satisfactory as noted from the exterior. Thresholds close to exterior decks or landings are susceptible to water intrusion, make sure they are protected and weather tight.

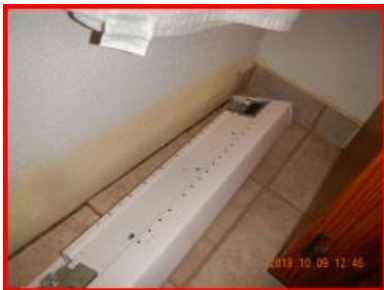
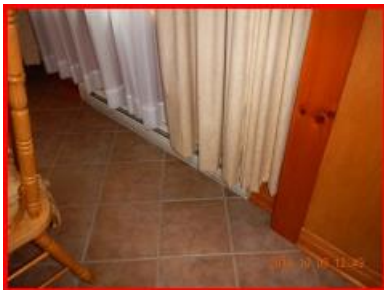
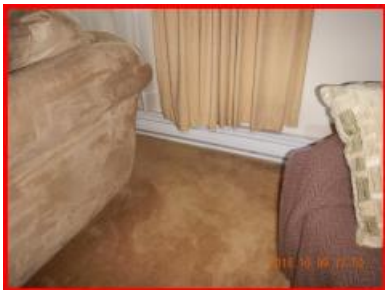
*Electric Heat:*

The primary source of heat is electric resistance heating. **The heater should always be in a stable upright position with at least 30 inches of space between the front of the unit and any other surface. Allow 6 inches of clearance above the heater for drapes or other flammable material. Heaters should not be operated in a closed area, such as beneath furniture, in cabinets, underneath or behind drapes.**

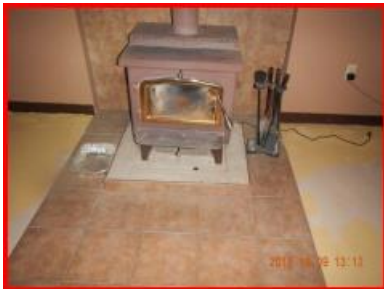
### Solid Fuel Heating

Solid Fuel Burning Appliance, is Listed  
Recommend cleaning appliance and chimney before use by a WETT certified technician/sweep.

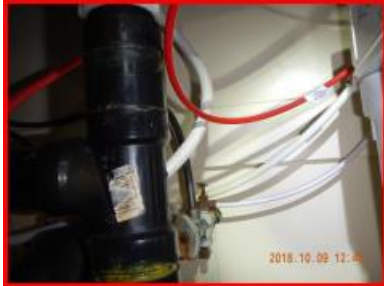
- Floor:* Satisfactory - The flooring in the kitchen is satisfactory.
- Countertops:* Satisfactory - The countertops in the kitchen are satisfactory.
- Cabinets, Drawers, and Doors:* Satisfactory - The cabinets, doors, and drawers are satisfactory in both appearance and function.
- Faucet and Supply Lines:* Attention needed: excessive corrosion noted, monitor in future for possible leaks.

There is deterioration of the drain pipes under the sink. Although there is currently no leak, there may be one in the future.

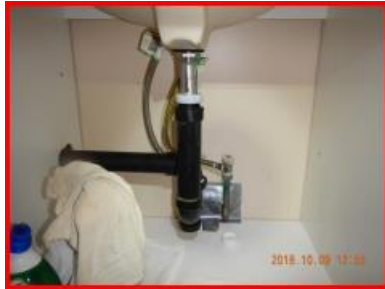
*Vanity Cabinet:* Satisfactory - The vanity cabinet and top in this bathroom are satisfactory.  
*Basin and Drain Fixture:* Satisfactory - The basin and drainage fixture appears to be satisfactory.  
*Faucet and Supply Lines:* Attention needed: excessive corrosion noted, monitor in future for possible leaks.

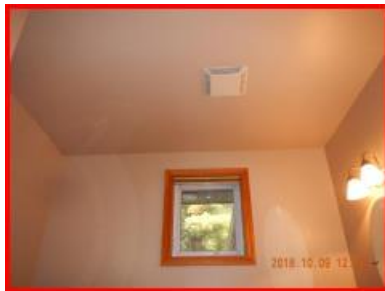
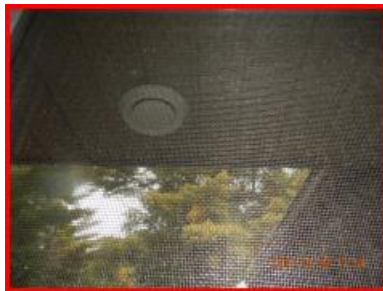
*Toilet Condition* Satisfactory - The toilet appears to be functional.  
*Tub:* There is a spa tub installed. The tub was filled with water and the jets activated to observe for proper action. The tub appeared to function properly.  
*Tub Mixing Valve:* Satisfactory - The tub mixing valve and the tub unit are in satisfactory condition.  
*Tub/Shower Drain:* Satisfactory - The tub/shower appears to drain at an acceptable rate.  
*Heat Source:* Satisfactory - There is a heat source in this room.  
*Ventilation Fans:* The ventilation fan vents to the exterior at the soffit. This was an acceptable installation at one time. It has been found that with proper attic ventilation it introduces moisture into the attic that must be removed from the attic. It is recommended that the vent be on an exterior gable wall.

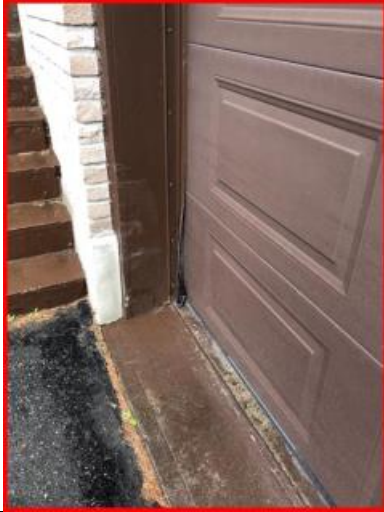
*Garage Type* The garage is attached.  
*Size of Garage:* One car garage.  
*Number of Overhead Doors* There is a single overhead door.  
*Overhead Door and Hardware Condition:* **Attention Needed** - The overhead door needs some minor repair. The overhead door weather seal needs some repair, or the overhead door needs adjustment.
