Report: Sample 0002

Inspection Address: 321 Old Road, Mytown, ON

Date: May 12, 2018

Confidential Inspection Report

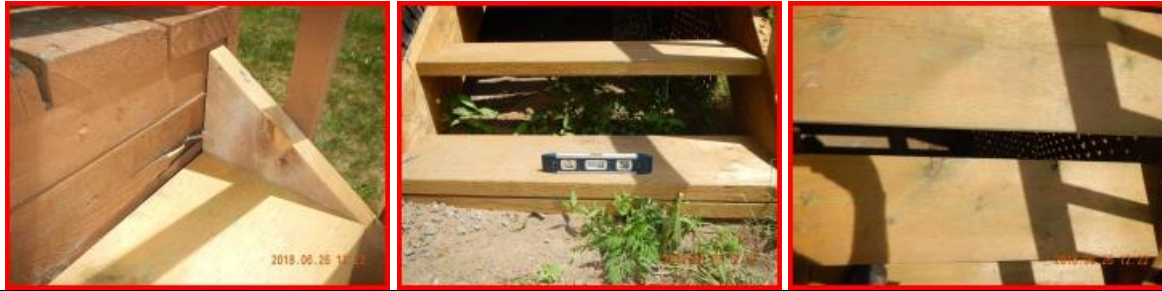
Entryway Stoop Materials Wood.
Entryway Stoop: Stairs are not level and not secure.
Create a level approach to the stairs.
Leading edge of treads are not over the tread below.

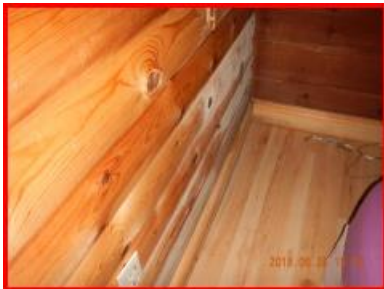
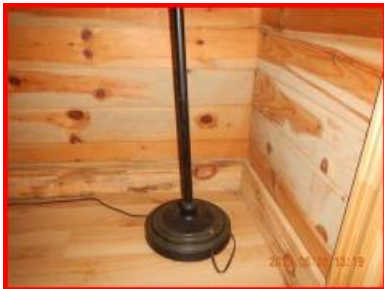
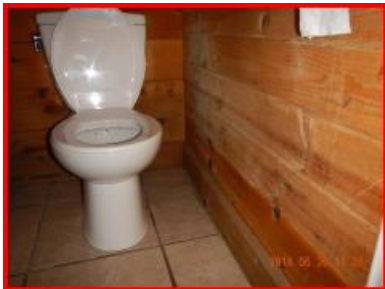
Yes. There is a mould or fungus noted on the covering material of foundation walls. This inspection does not include testing for mould type or toxicity. Further testing is recommended and needed to determine the type and the toxicity levels. A serious health hazard may exist from what appears as a simple mould. Testing for airborne mould is also excluded from this inspection.

Please consider having testing completed to protect your investment and your family's health.

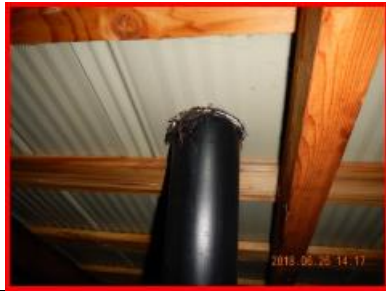
Slope: Medium slope is considered to be between 4 in 12 and 6 in 12.
Flashing: A proper flexible flashing designed for use with metal roofing should be used at the plumbing vent stack.

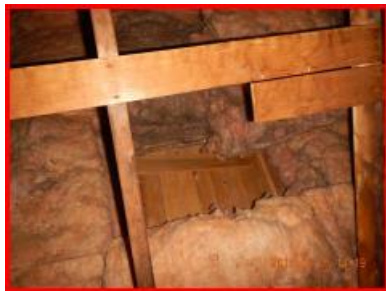
Insulation Noted: **Attention Needed** - The attic insulation does not appear to be correctly installed or needs attention.

There is an average of at least 8" of insulation installed.

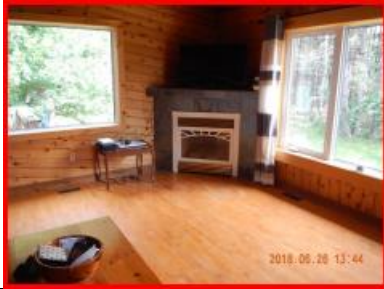
Location of Fireplace: Living room.
Type of Fireplace: Insert.
Fireplace Fuel: Gas - The fireplace is designed to use gas fuel only.
Source of Combustion Air: Outside air is used for combustion. This is the most efficient system.
Comments Maintenance and cleaning required.

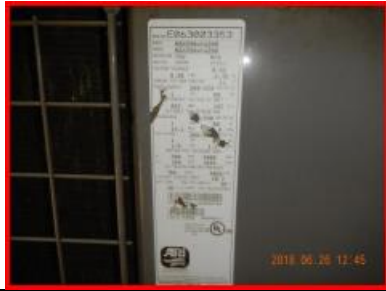
Type: Refrigerator/Split System. Electricity-powered.
Unit Tested: Yes.
Insulation Wrap on the Suction Line: Satisfactory.
Condenser Clear of Obstruction: Satisfactory.
Condenser Cabinet Level: **Action Necessary** - The condenser pad should be solid and within 5-10 degrees of level. The current condition does not allow stability and may prohibit adequate lubrication. Action is recommended before continued use.

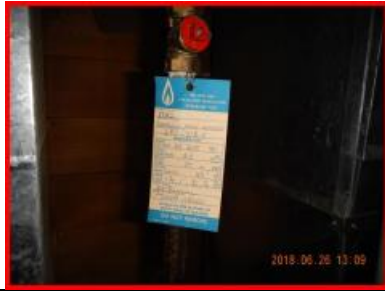
The fuel source is natural gas. Gas Valve, There is a gas valve cutoff installed adjacent to the furnace without a handle.

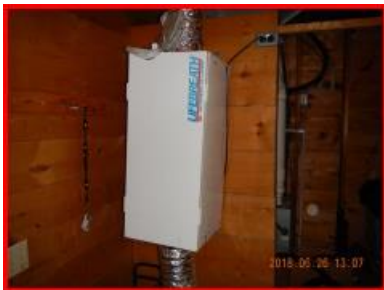
An air cleaner has been installed it is not an HRV. Be sure to maintain this unit according to manufacturer's recommendations.

Inlet and Outlet Vents Inlet vent requires cleaning at least annually - a clogged vent will hinder the performance and possibly cause damage.

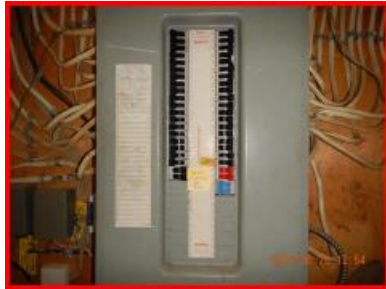
Yes - Identification of the circuits and the appliances or areas they control are clearly marked. This inspection does not verify the accuracy of this legend. The legend is not complete.

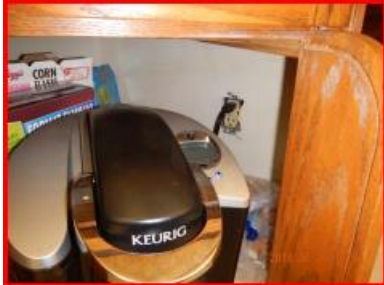
This kitchen does not have Ground Fault Circuit Interrupt outlets installed. The age of the structure may predate the required installation; however, for safety considerations, it is suggested that one be installed at any location within 1.5 meters of a water source. Split receptacles are allowed to be changed to GFCI outlets.

Attention Needed - At least one outlet noted in the kitchen needs a new outlet cover.

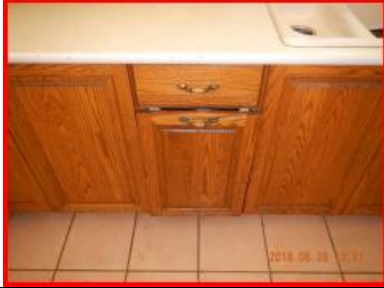
Cabinets, Drawers, and Doors: Adjustment of doors will help with alignment.

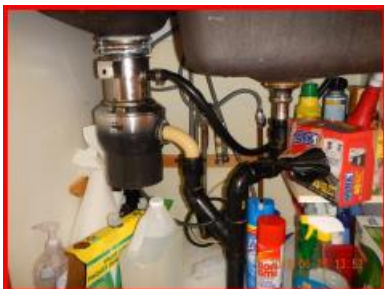
Action Necessary - The food waste disposal did not activate using normal controls. Further investigation is needed to determine if repairs or replacement should be done.

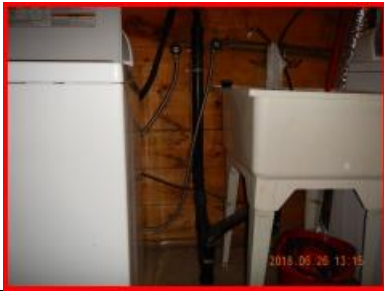
Yes, Water supply valves. **Action Needed** - There is not a properly installed trap with at least 18 inches of vertical stand pipe on the drain line.

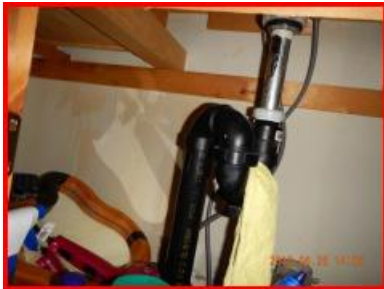
DRAIN LINES- S-TRAP PRESENT: An S-trap is found in the drainline under the sink. S-traps have a tendency to siphon out the liquid seal in the trap when a basin of water is emptied. They are no longer used in new construction and should be eliminated where practical when renovations or plumbing repairs are under consideration. In the meantime, simply running a bit more water down the drain after a basin of water drains will act to restore the liquid seal in the trap in the event siphoning occurs.

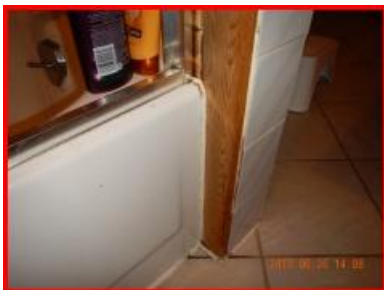
There are signs of possible water intrusion.

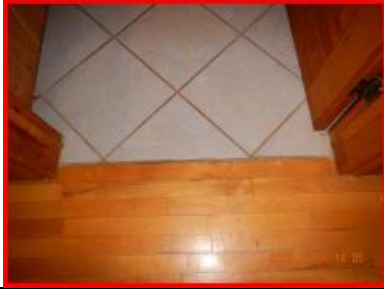
Tiled flooring surfaces should have caulk not grout where two different materials meet or add a transition.

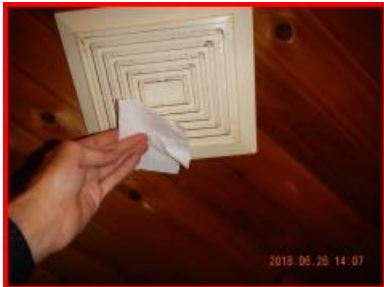
Action Necessary - There is an exhaust fan installed, but it would not activate using normal controls. Repair or replacement is necessary. The ventilation fan vents to the exterior at the soffit. This was an acceptable installation at one time. It has been found that with proper attic ventilation it introduces moisture into the attic that must be removed from the attic. It is recommended that the vent be on an exterior gable wall. There is evidence that suggests the ventilation duct requires cleaning.

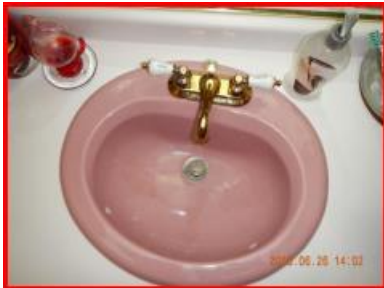
Do It Your Self work. Have a qualified licensed technician perform repairs and upgrades.

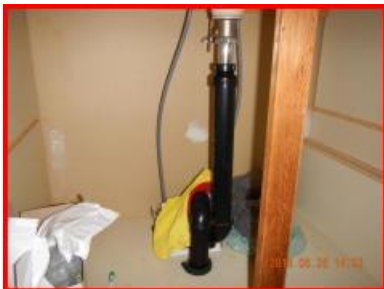
DRAIN LINES- S-TRAP PRESENT: An S-trap is found in the drainline under the sink. S-traps have a tendency to siphon out the liquid seal in the trap when a basin of water is emptied. They are no longer used in new construction and should be eliminated where practical when renovations or plumbing repairs are under consideration. In the meantime, simply running a bit more water down the drain after a basin of water drains will act to restore the liquid seal in the trap in the event siphoning occurs.

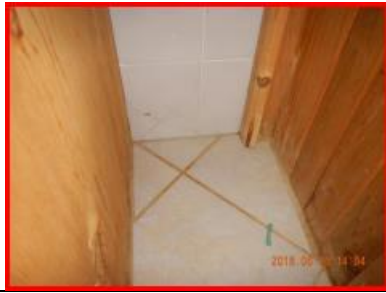
Walls: **Action Necessary** - There are some cracks or deterioration in the walls in the bathroom that need repair.

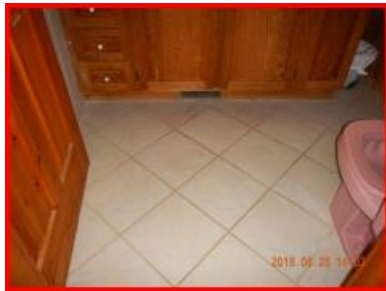
Tiled flooring surfaces should have caulk not grout where two different materials meet or add a transition.

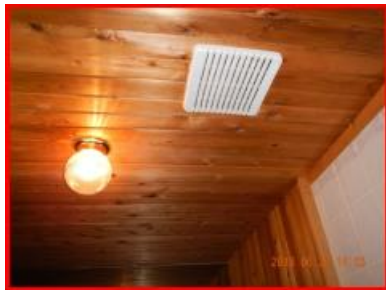
The ventilation fan vents to the exterior at the soffit. This was an acceptable installation at one time. It has been found that with proper attic ventilation it introduces moisture into the attic that must be removed from the attic. It is recommended that the vent be on an exterior gable wall. There is evidence that suggests the ventilation duct requires cleaning.

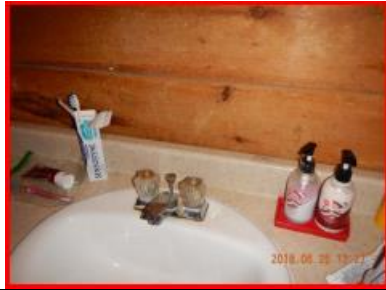
Wall material is not water resistant and will deteriorate - recommend a backsplash of appropriate materials for wet location be installed.

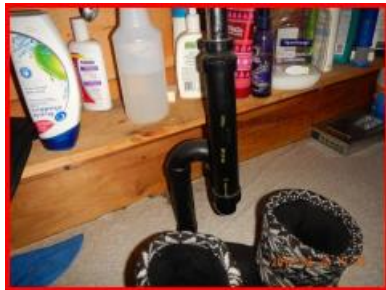
DRAIN LINES- S-TRAP PRESENT: An S-trap is found in the drainline under the sink. S-traps have a tendency to siphon out the liquid seal in the trap when a basin of water is emptied. They are no longer used in new construction and should be eliminated where practical when renovations or plumbing repairs are under consideration. In the meantime, simply running a bit more water down the drain after a basin of water drains will act to restore the liquid seal in the trap in the event siphoning occurs.

Attention Needed - The basin or drainage fixture needs attention. The lavatory drains slowly. There may be some blockage either in the fixture or the drain line.

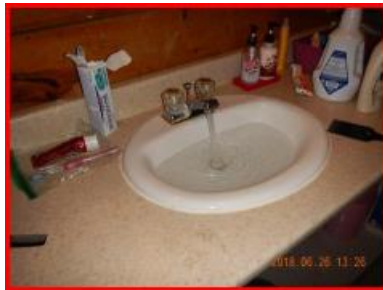
Attention needed: excessive corrosion noted, monitor in future for possible leaks.

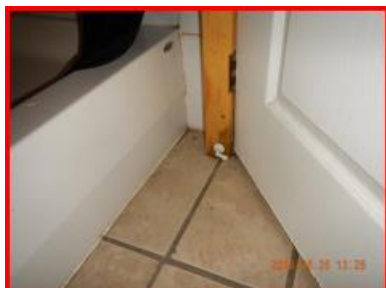
There are signs of possible water intrusion.

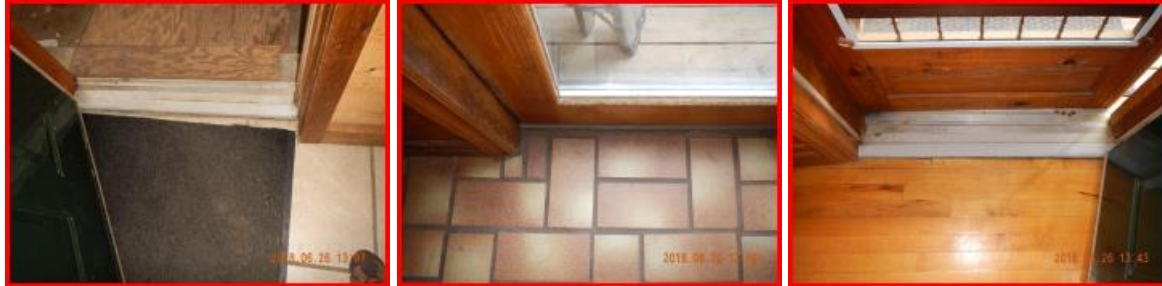
Tiled areas both vertical and horizontal surfaces should have caulk not grout in joints along inside corners and where two different materials meet.

Seal with caulk and trim where the floor meets the threshold to prevent damage.

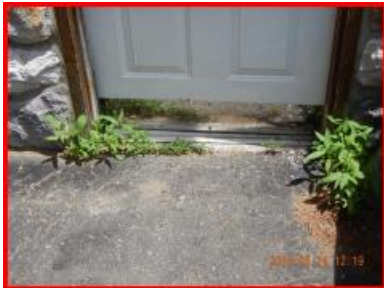
Automatic Overhead Door Opener: The overhead door opener appears to function appropriately.
Safety Reverse Switch on the Automatic Opener: Yes - The door opener is equipped with an automatic reverse safety switch. There is an electronic beam safety reverse system installed. It is functional.
Outside Entry Door: Threshold, is close to exterior grade or landings are susceptible to water intrusion, make sure they are protected and weather tight - hidden damage may be present.

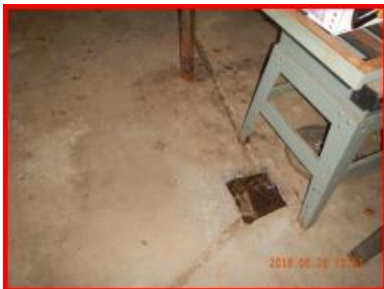
Floor Condition: Satisfactory - The garage floor is in satisfactory condition.
Floor Drain: Yes - There is a floor drain installed. This is a handy feature for easier cleanup from rain and snow dripping off the cars. It is not usually allowed due to the possibility of soil contamination from fuel, lubricant, and coolant.

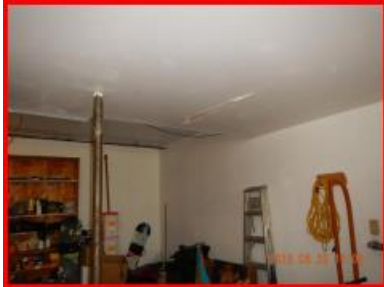
Separation:

Action Necessary - There are some water stains in the ceiling that show evidence of a current water leak. Further investigation is needed.
